Glenwood Springs Bike and Pedestrian Transit Access Study

Final Report

LSC Transportation Consultants, Inc.
516 North Tejon Street
Colorado Springs, CO 80903
(719) 633-2868

February 28, 2008

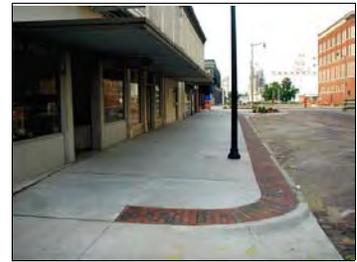
**Figure III-1
Attached Sidewalk**

Sidewalks can be attached to the roadway traveled way or separated by a buffer area such as a planted strip. If there is not a buffer area, a curb should be provided, as shown in Figure III-1. The main advantage of having a buffer area is that pedestrians are kept at a greater distance from moving vehicles and therefore pedestrian safety is increased. In many cases, on-street parking can work as a buffer area. Nearly all sidewalks along the major arterials are attached

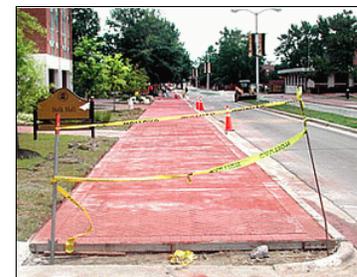
**Figure III-3
Brick Sidewalk**

The most common material used to make sidewalks is concrete. However, there are several alternative materials including asphalt, brick (as illustrated in Figure III-3), and crushed stone. Regardless of the material used, sidewalks should have a stable, firm, and slip-resistant surface. Figure III-4 shows typical roadway cross sections with attached and detached sidewalks based upon the current engineering design standards. Nearly all sidewalks in Glenwood Springs are constructed of concrete.

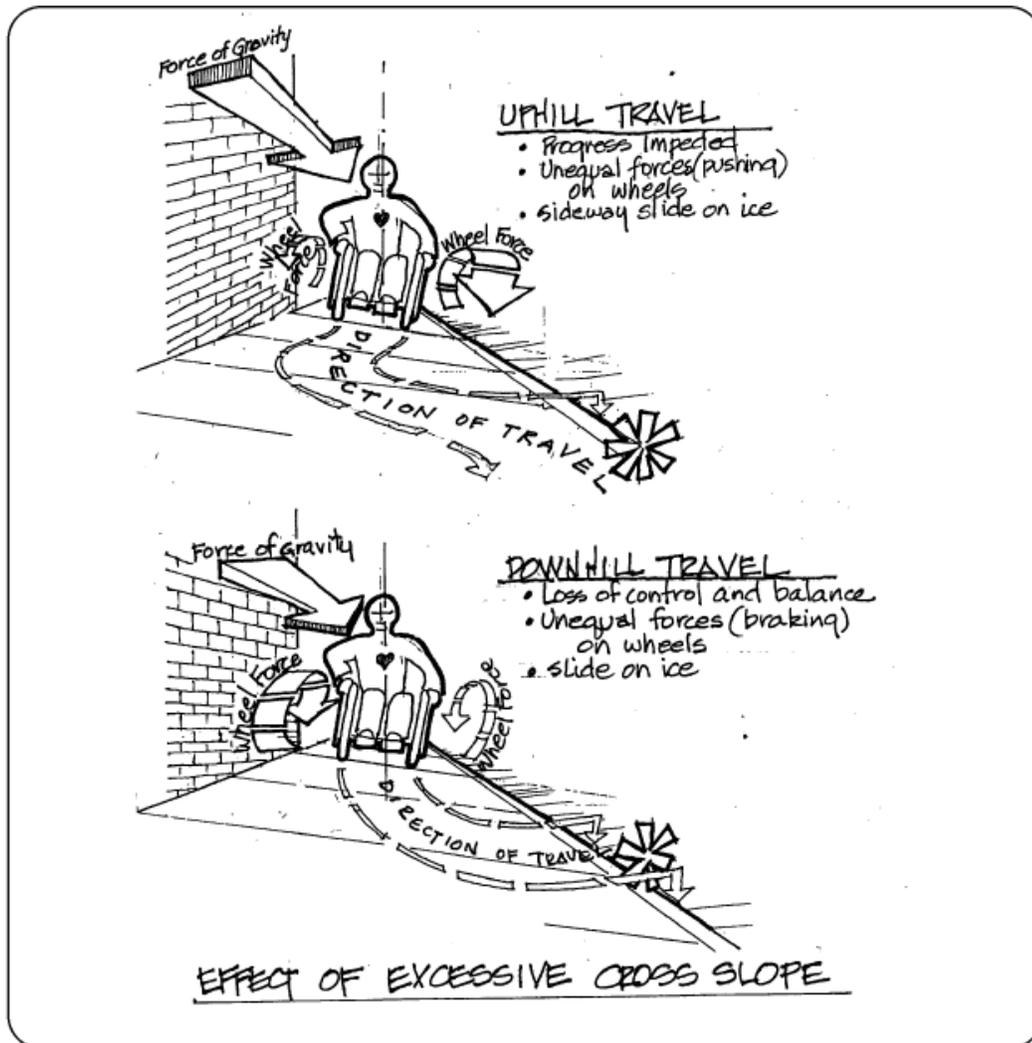
**Figure III-7
Excessive Cross Slope**

Excessive cross slope is a major barrier to travel along sidewalks for pedestrians who use wheelchairs and scooters. Sidewalk cross slope should be limited to 1:48 (two percent). Pedestrians who use manual wheelchairs and walking aids must expend additional effort to counteract the effects of cross slope. This is particularly difficult when the sidewalk running slope is steep. A wheelchair or walker needs a planar surface for travel. Where a drive wheel, caster, or leg tip loses contact with the surface, control and stability are at risk. Not only can this cause a risk of tipping, the undue stress on wheel bearings and drive motors can be a costly expense to individuals. Figure III-7 illustrates the problematic issues with excessive cross slopes.

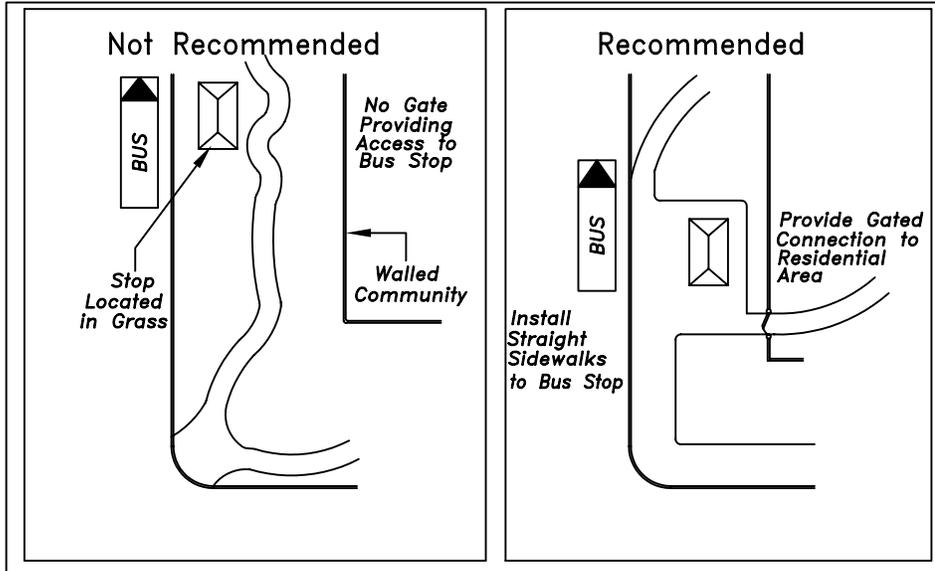
These barriers must be carefully planned so that at least pedestrian ways are allowed and placed throughout the barriers so that no development is completely enclosed. The main point of the walled communities is to minimize unnecessary vehicle traffic and to incorporate a sense of place and community. While this is vitally important to those who reside in the area, it is also important to realize and understand the connectivity of a bicycle and pedestrian network. Figure III-8 illustrates examples of recommended and not recommended methods of providing bus stop access from a walled residential area.

Examples of Recommended and Not Recommended Bus Stop Access From a Walled Residential Area

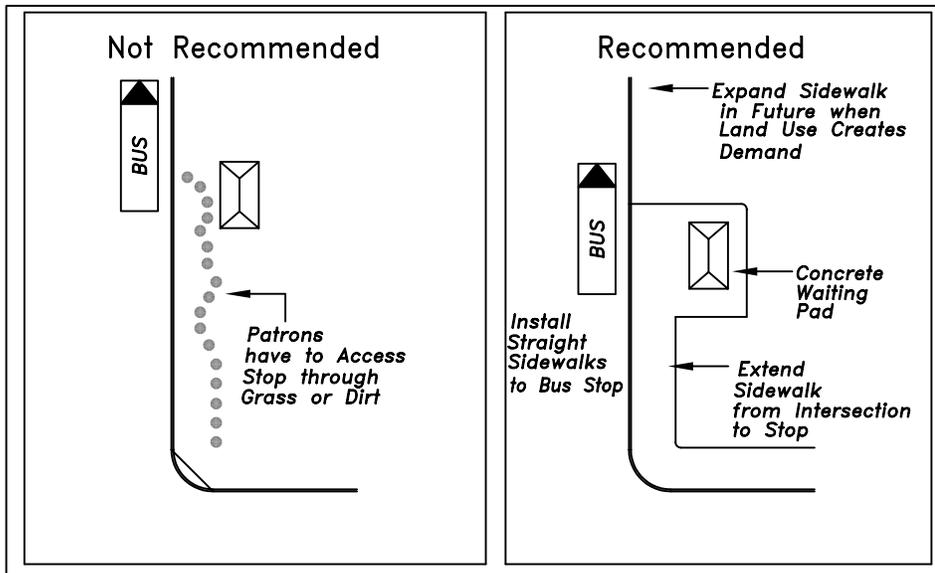
Examples of Recommended and Not Recommended Bus Stop Access in a Rural Area

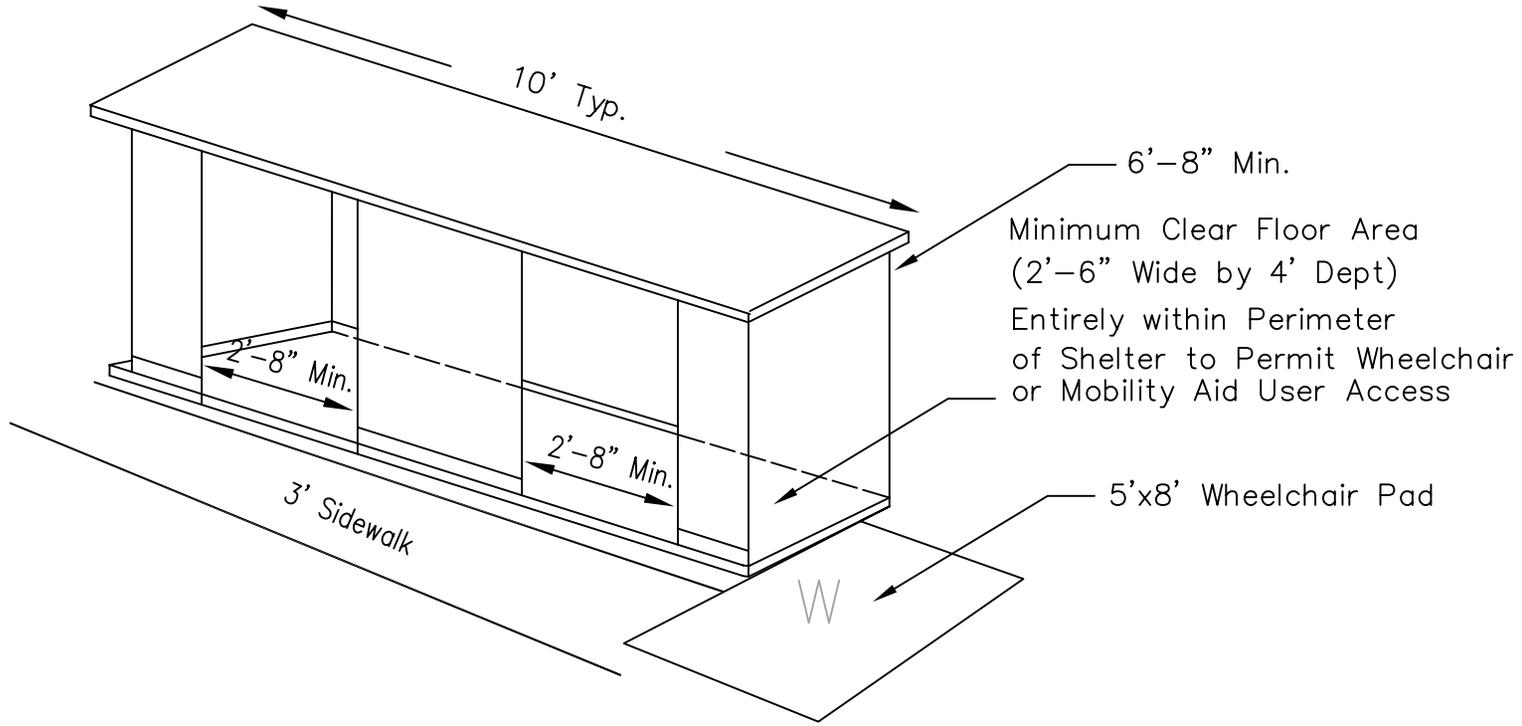
Figure III-9 illustrates the recommended bus stop design for either a rural or urban area. As shown, the recommended design encompasses the baseline requirements of the Americans with Disabilities Act and allows patrons to have direct access to the transit vehicle. Sidewalks are common in Glenwood Springs, and it should be feasible to have a concrete landing pad at each stop. The recommended bus stop, as illustrated, provides an accessible and comfortable waiting area for all transit users. Wheelchair users in particular require a stable, level, and unobstructed landing pad for the wheelchair lift or ramp to be deployed when boarding and alighting the bus. With respect to the waiting area, wheelchair users also require adequate spacing at the stop to wait, as well as adequate space to maneuver from the waiting area to the landing pad. Anecdotal experience throughout the country shows that a curb of some sort is usually necessary in order for a wheelchair user to be able to easily get on or off a bus with a ramp, even if the ramp is allegedly “ADA compliant.” As virtually all transit passengers are also pedestrians on one or both ends of their trip, well-planned access ways that provide direct, safe, and attractive access to bus stops can significantly encourage transit use.

ADA Minimum Dimensions of a Passenger Loading Pad and Shelter

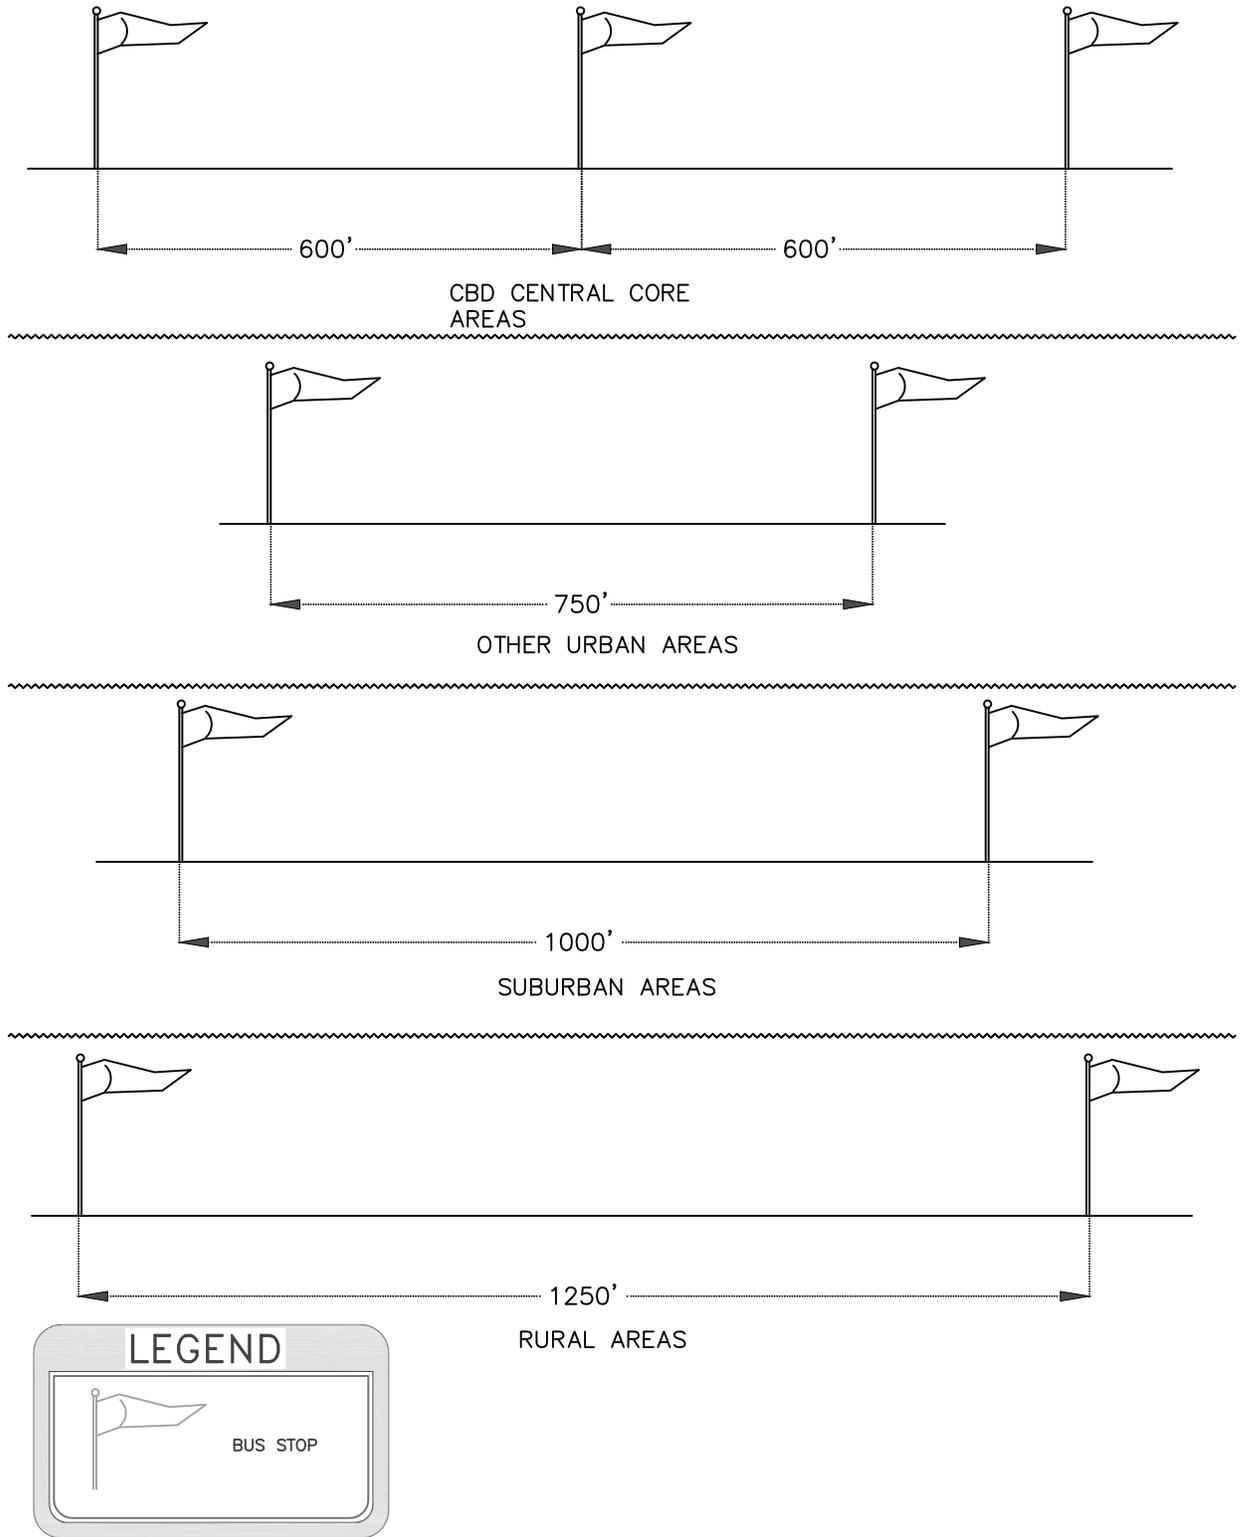
Currently, Glenwood Springs does not have a standard for bus stop spacing. Table III-1 provides typical bus stop spacing standards. As shown, bus stop spacing in the Glenwood Springs area is consistent with typical spacings for urban areas. However, some areas may need to have decreased spacing between stops. Also, determining the level of pedestrian access to these stops is an important function in spacing. It would not make sense to have stops every 800 feet if there are no adequate pedestrian facilities to access these stops. Figure III-10 illustrates the recommended spacing.

**RECOMMENDED BUS
STOP SPACING**

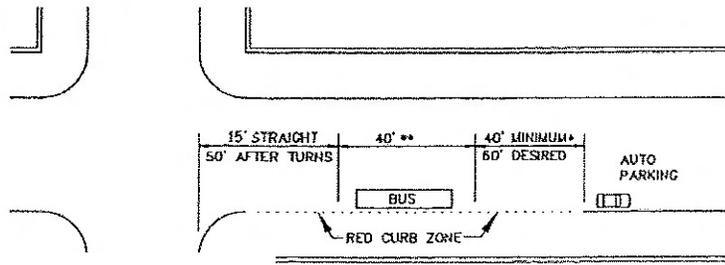
Figure III-11

Far-side bus stops are recommended at intersections where sight distance or signal capacity problems exist, where parking conditions are critical, where right or left turns by general traffic are heavy, and where buses make left turns. In general, transit agencies and traffic engineers prefer far-side stops as the standard unless conditions indicate that near-side or mid-block stops are required. The recommended far-side bus stop is illustrated in Figure III-11. Near-side bus stops shall be the preferred alternative where buses make right turns, and shall also be an alternative at intersections where transit flows are heavy, but traffic and parking conditions are not critical. The recommended near-side bus stop is illustrated in Figure III-12.

Far Side Stop

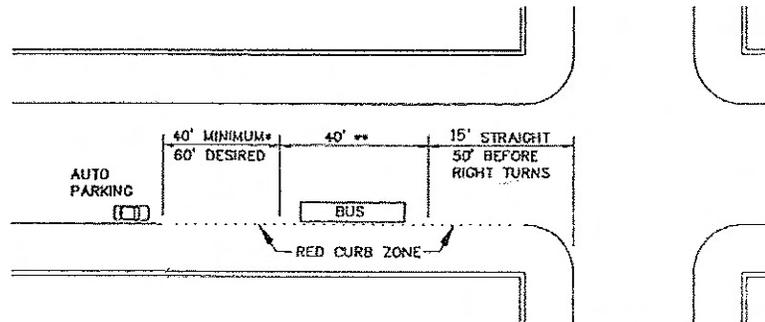
Figure III-12

Near Side Stop

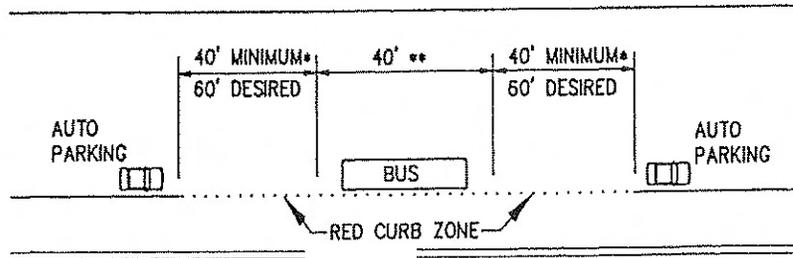
Figure III-13

Mid-block bus stops shall be an alternative in strip commercial areas where the block faces are longer, with multiple destinations served within the block, in downtown areas where multiple routes require long loading areas that might extend an entire block, or where traffic, physical, or environmental conditions prohibit near or far-side stops. The recommended mid-block bus stop is illustrated in Figure III-13.

Mid-Block Stop

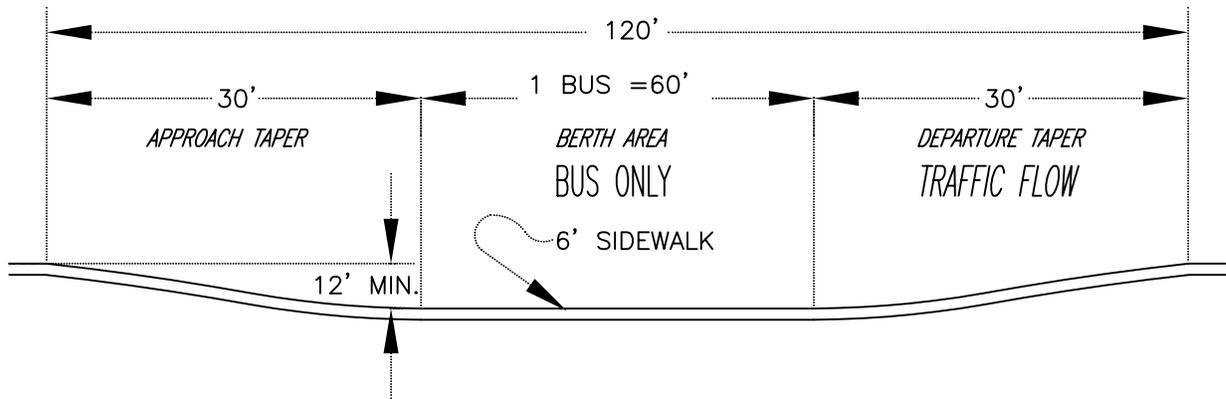
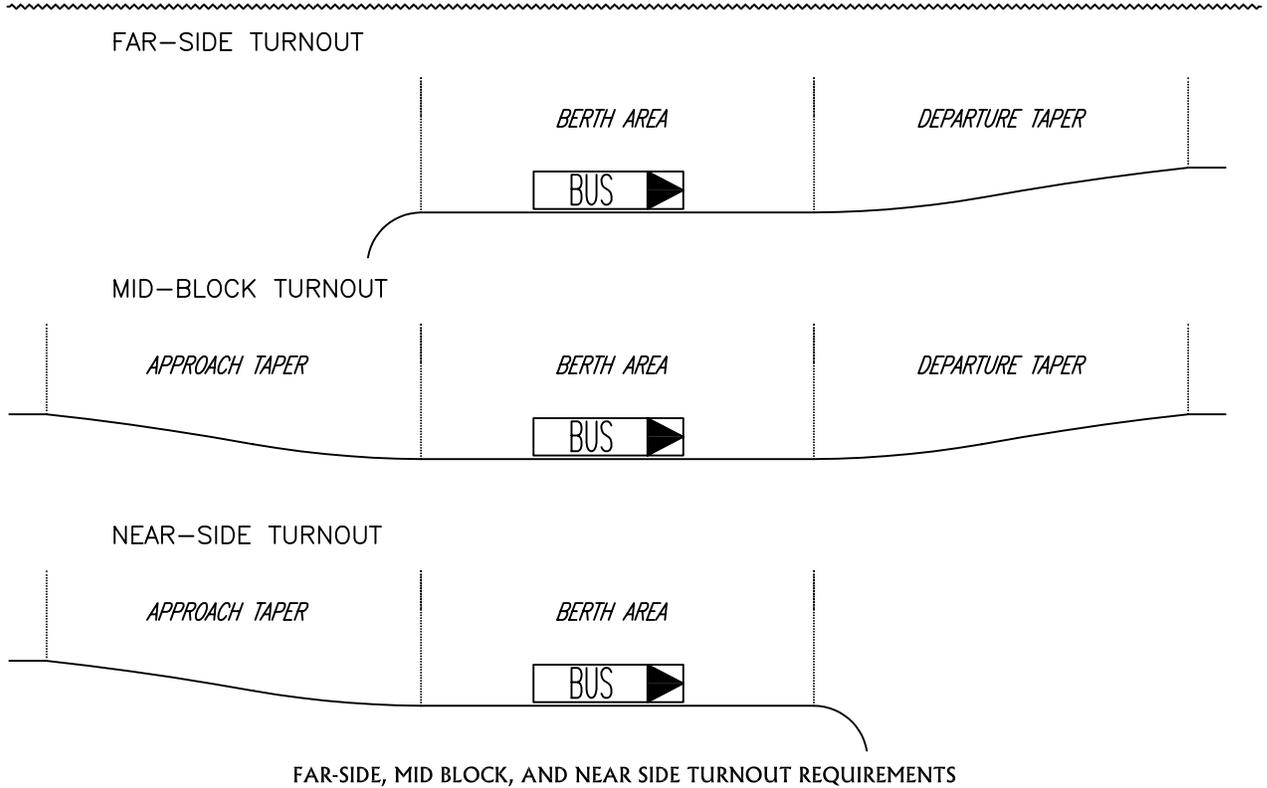
For stops located at low-speed—low-volume roadways without unusually high passenger activity—it is appropriate for transit buses to stop in the travel lane. This condition applies to many of the Glenwood Springs stops located off of the state highways or urban arterial roadways. The recommended bus pullout is illustrated in Figure III-14.

Bus Pullout Design

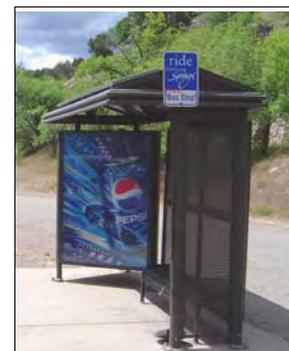
**Figure III-15
Current Signage**

It is recommended that signs be posted at all bus stops. Signed stops are a key element in informing passengers where service is available. In addition, bus stop signs provide a permanent “presence” on the street that substantially increases public awareness of the transit program among riders and non-riders alike. The most common type of sign is a flag sign displaying route and passenger information. The design of bus stop signs should be standardized throughout the system so they are instantly recognizable. It is useful for signs to be double-sided (so they can be read from both directions) and reflectorized (for easy night reading). It is recommended that bright colors be used for easy bus stop identification. Characters and background of signs should have a non-glare finish however, with characters and symbols contrasting from their background. Currently, all existing Glenwood Springs signs are red, white, and blue, as shown in Figure III-15. The design elements on the sign should include the logo, a phone number for transit information, and, optionally, the major destination of the routes available at the stop. The bus stop sign should, wherever possible, be placed even with where the operator is trained to stop the front door of the bus to let patrons know where to stand. Signs closer to the curb should be positioned to face toward the sidewalk to prevent bus mirrors from hitting the signs. Placement within an existing sidewalk of four feet or less width should be avoided wherever possible. Signs can be located on existing poles, such as streetlights or other traffic information signs. Unprotected sign posts should be of the break-away type to minimize injuries and damage resulting from motor vehicle accidents.

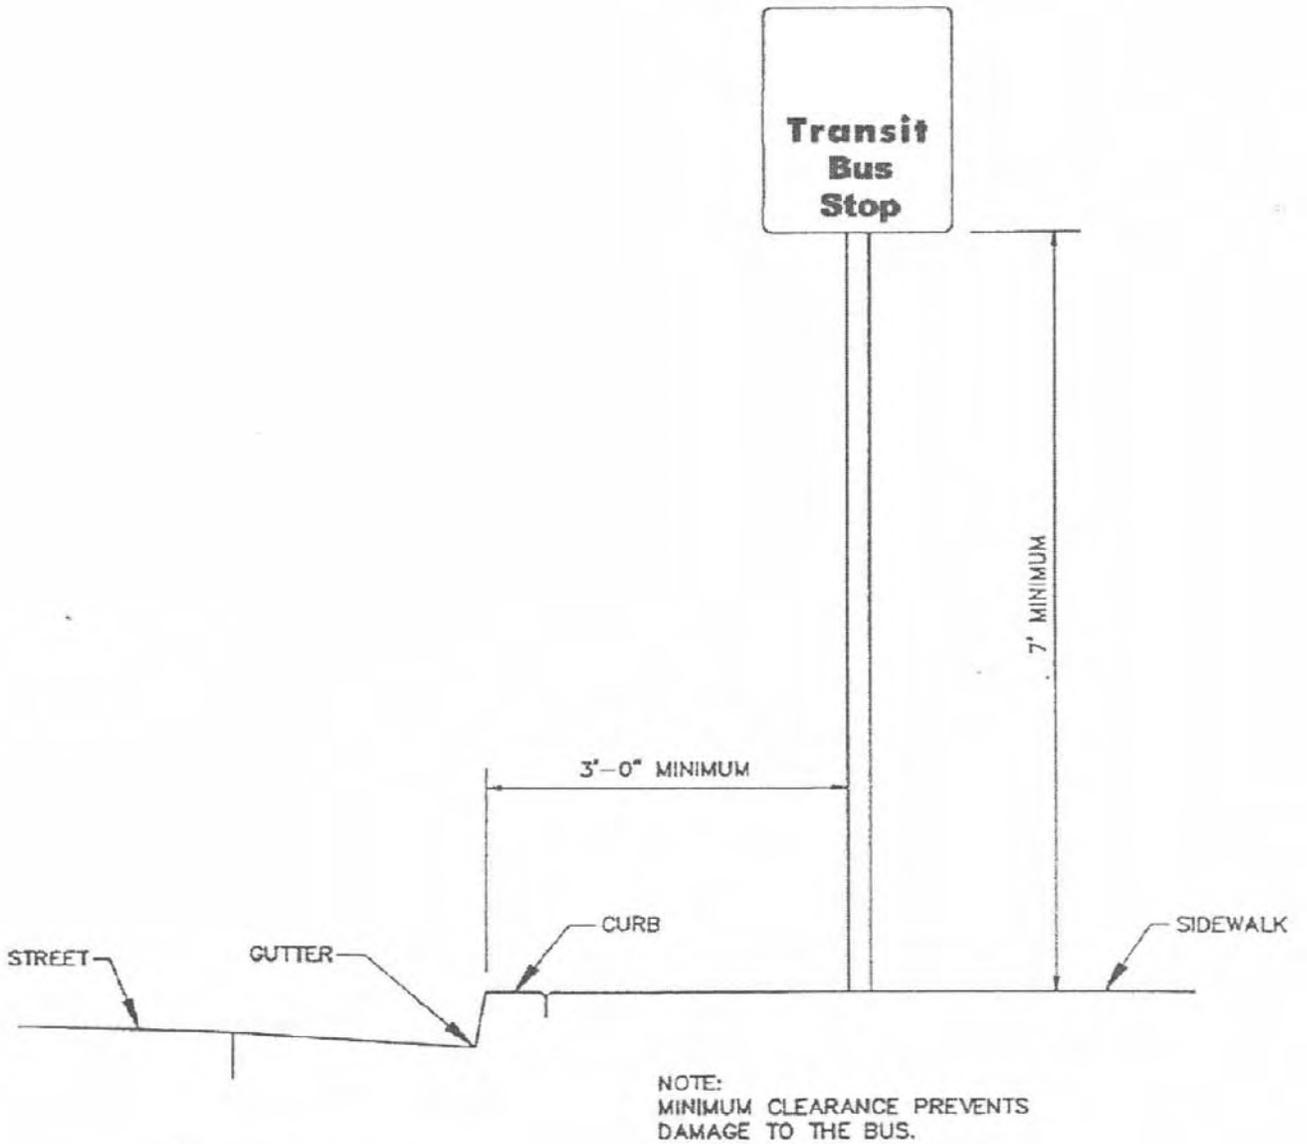
Figure III-16

In light of budget constraints, it is recommended that the City of Glenwood Springs utilize the latter of the two options described above. It is also recommended that a community meeting(s) be conducted in order to determine which method is most effective for visually-impaired local patrons. Braille markings may help some passengers, but many persons with visual disabilities do not use Braille. Minimum ADA design implications apply to the installation of new or replacement signs and include the following and are illustrated in Figure III-16.

Minimum Stop Sign Design

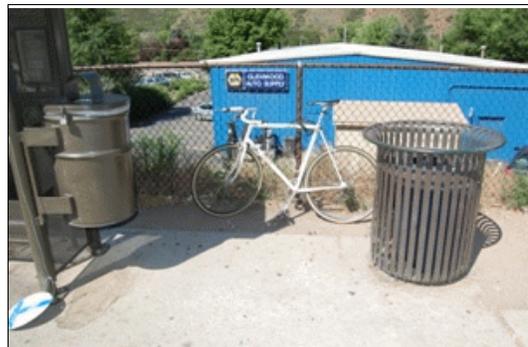
**Figure III-17
Bicycle at Stop**

It is appropriate to provide bicycle parking at some bus stops. The provision of bike parking facilities discourages bicycle riders from locking their bikes to the bus stop structures or to structures on adjacent properties, as illustrated in Figure III-17 near Wal-Mart, and reduces visual clutter by locating bikes together in one area. Bicycle parking facilities should be located away from other activities to reduce congestion and improve safety. At lighted stops, the bike parking should be located near the lighting to offer protection from theft. The bike parking should not restrict views into the bus stop area. It is recommended that racks for bike parks be provided at bus stops where there is the potential for a high level of patrons to access by bike, such as near educational facilities.

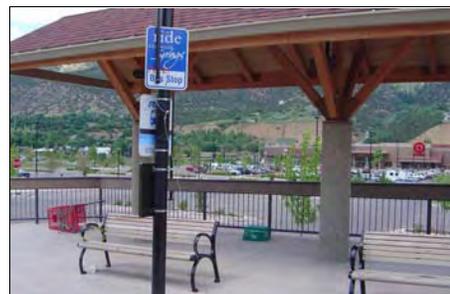
**Figure III-18
Glenwood Meadows**

one or more shelters and benches, adequate lighting, an auto drop-off area, bicycle parking, motorcycle parking, toilet, kiosks, and appropriate landscaping. Figure III-18 provides a photo of the current park-and-ride lot in west Glenwood. Note, the benches should be relocated under the protective structure.

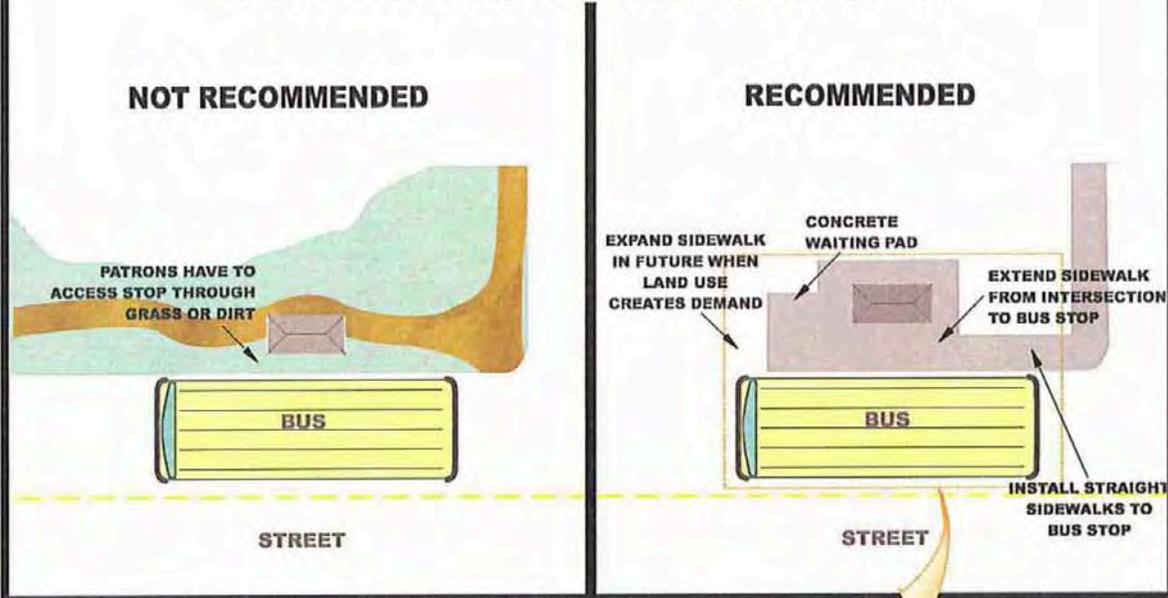
EXAMPLES OF RECOMMENDED AND NOT RECOMMENDED BUS STOP ACCESS IN A RURAL AREA

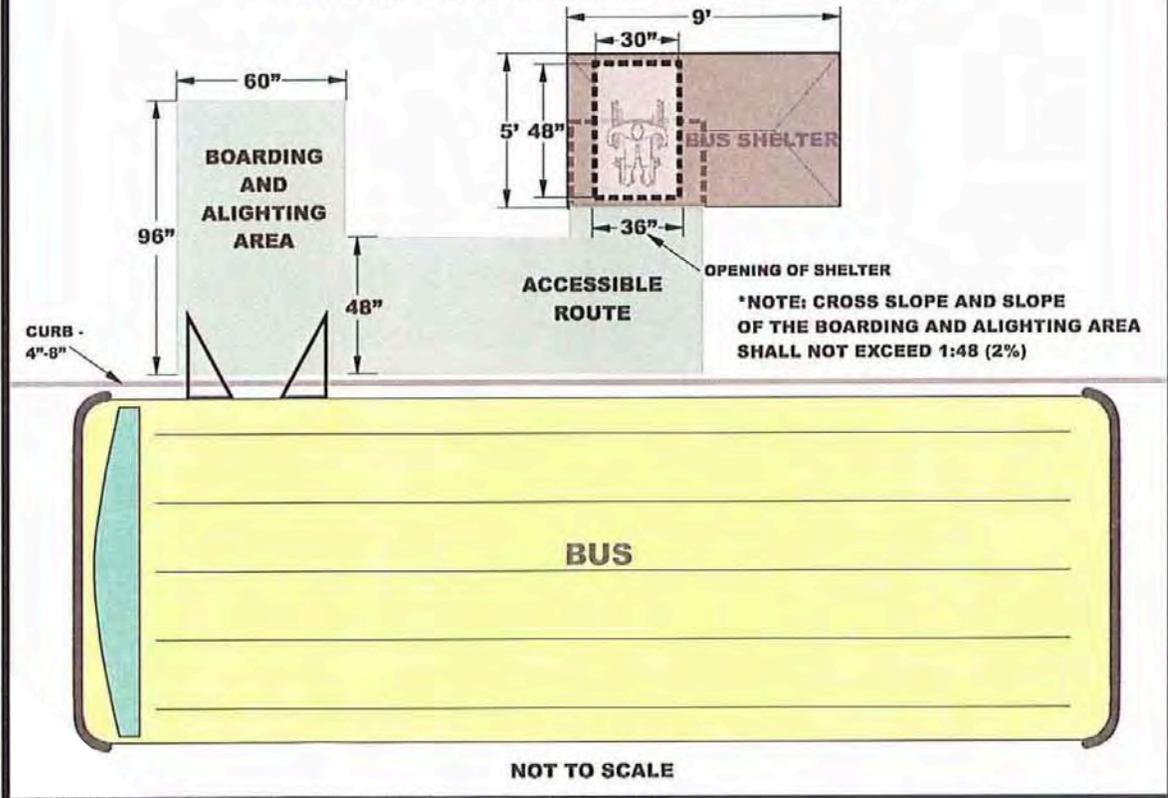
RECOMMENDED MINIMAL BUS STOP DESIGN

Minimum Bus Stop Design

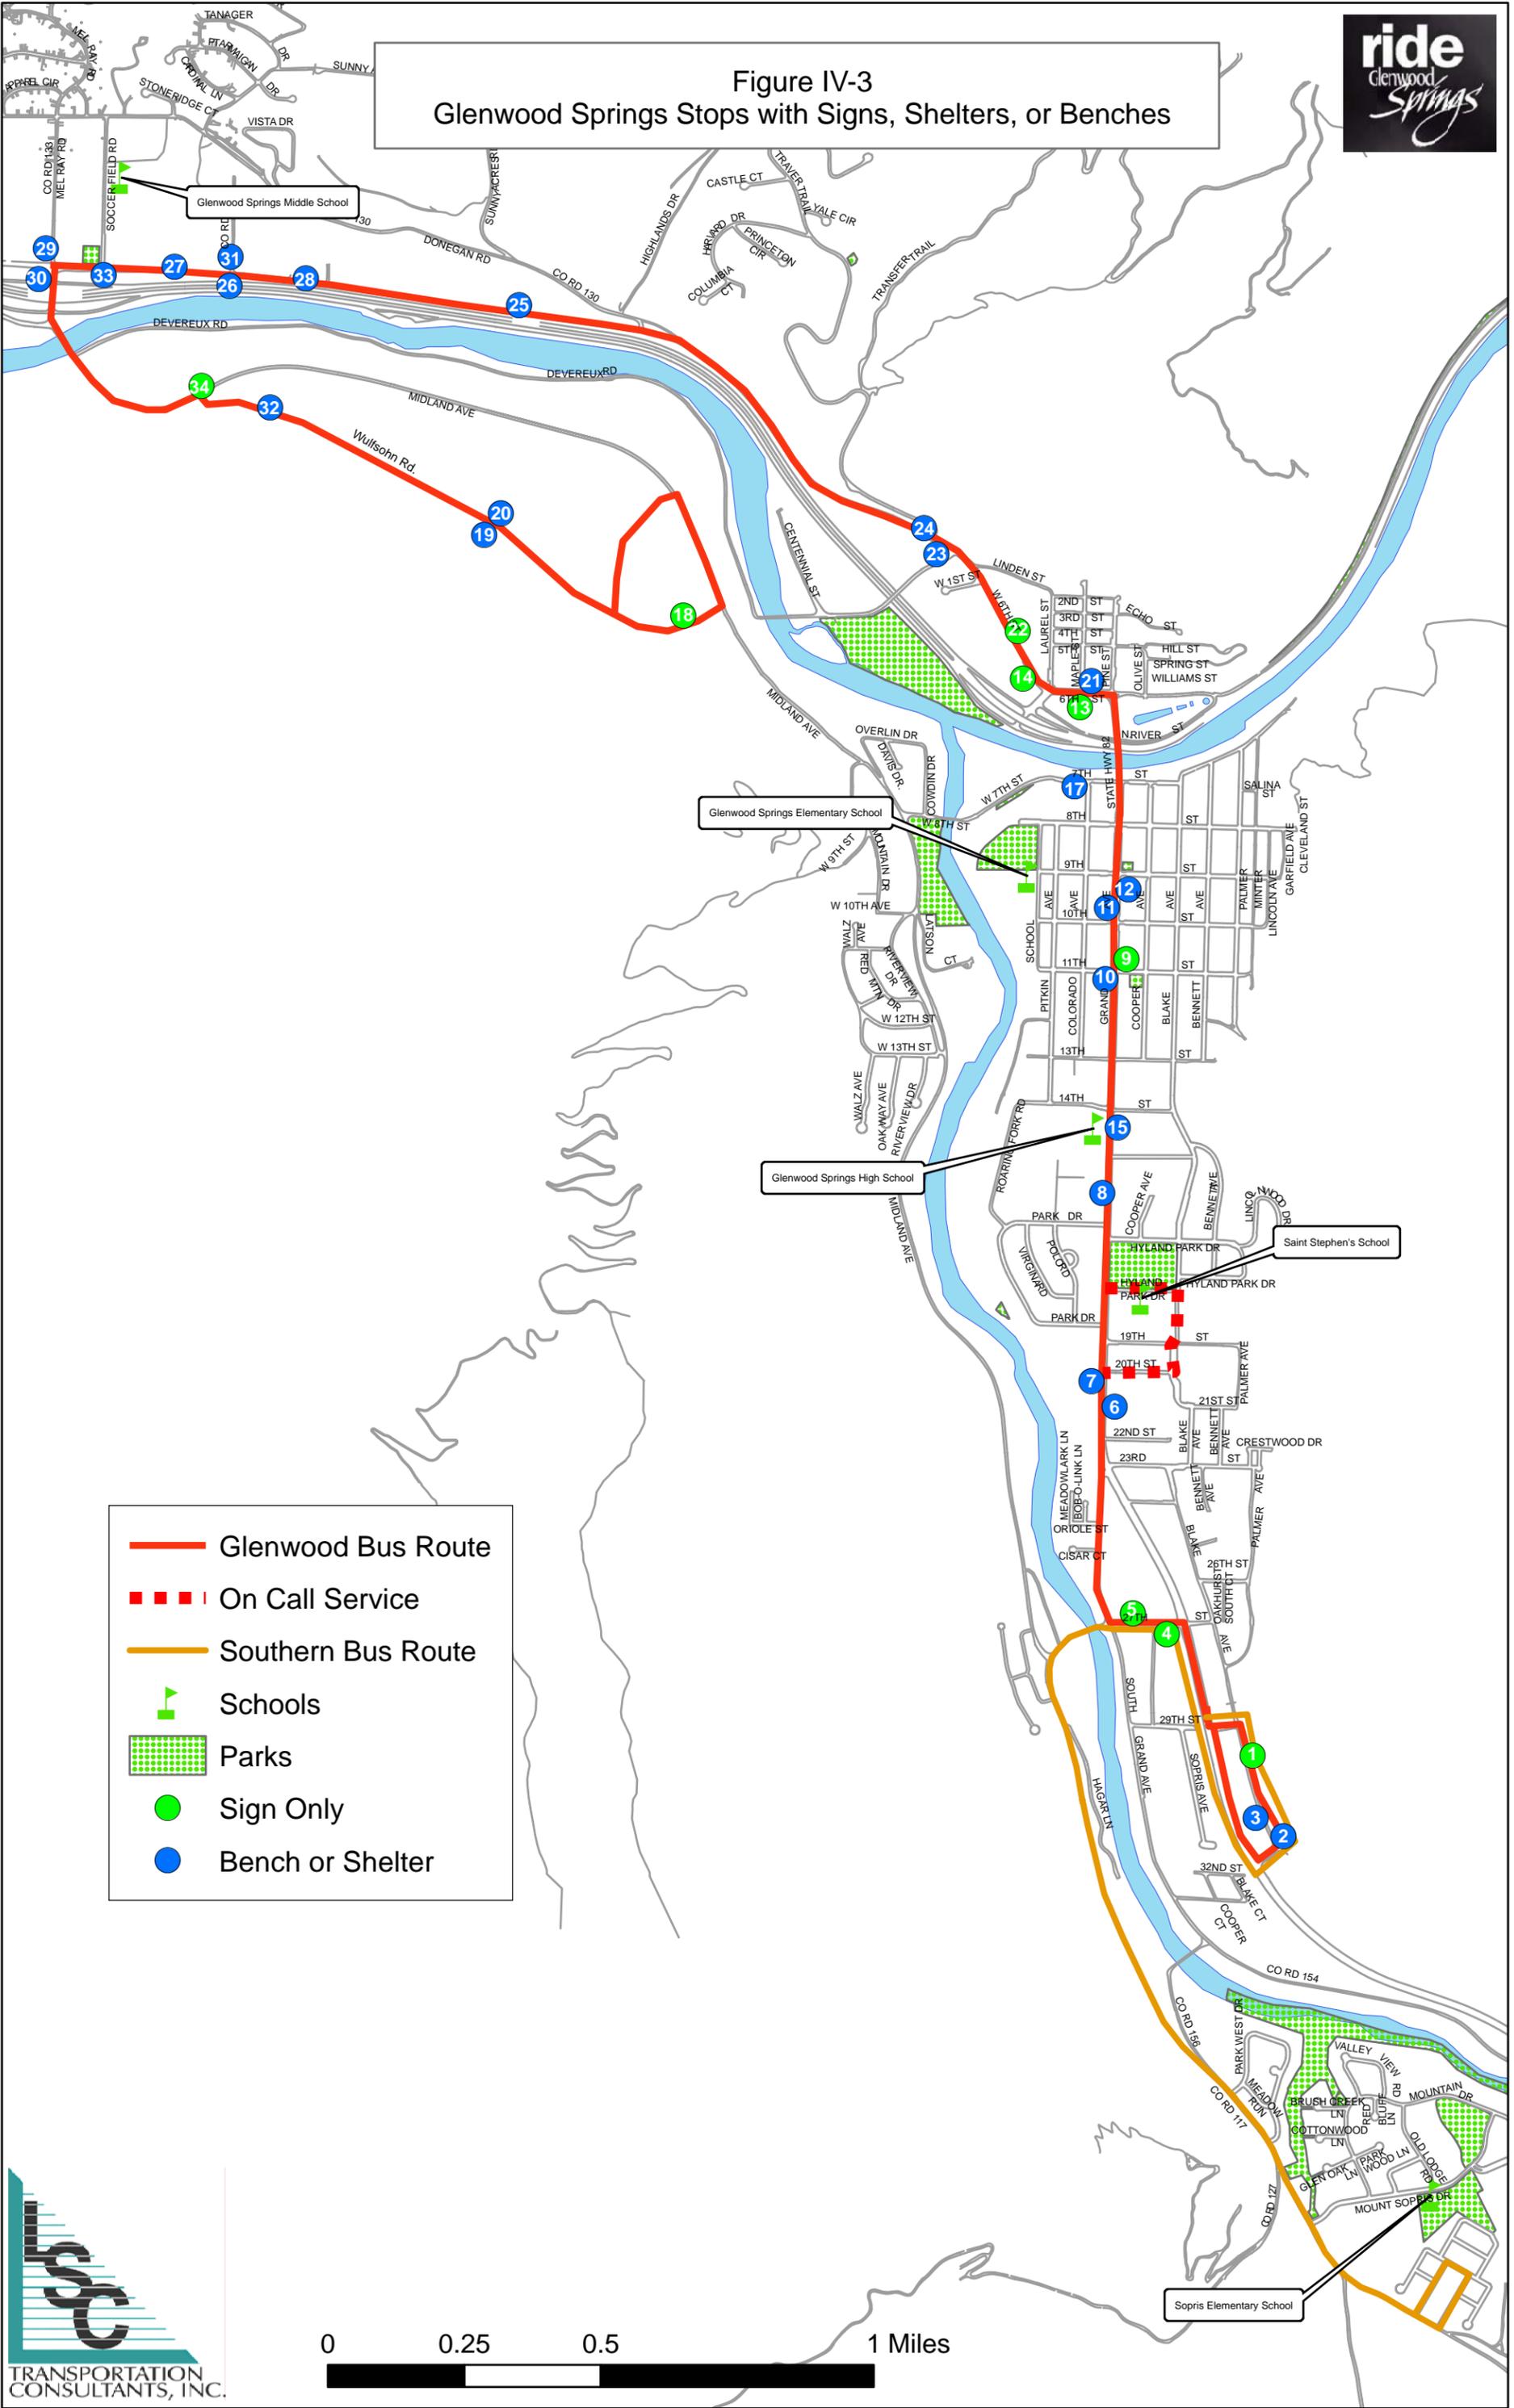
Figure IV-3
Glenwood Springs Stops with Signs, Shelters, or Benches

Figure IV-3 and Table IV-2 show the current Glenwood Springs stops with either a bench only or a shelter as well as the characteristics of those stops. Approximately half of the stops in the area have a current shelter in place. Typical shelters are illustrated in Figure IV-4. As shown, the shelters offer some protection from the elements; however, the advertisement on the shelters takes up nearly one-third of the shelter footprint. Trash receptacles are common; however, as shown, this one is in need of servicing.

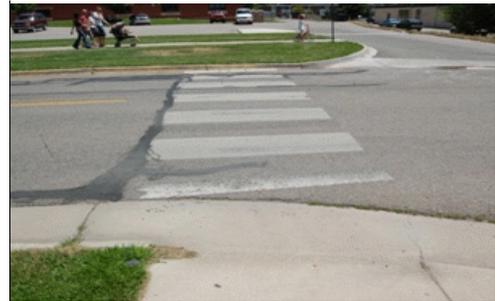
**Figure IV-9
Non-Existent Curb Cut**

Curb cuts, as illustrated in Figure IV-9, have no existing sidewalk to access. While this is not a common occurrence, it does illustrate the fact that crosswalks without curb cuts do exist. This location accesses a middle school just to the left of the photo.

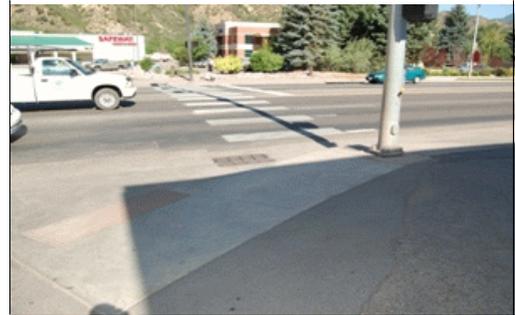
**Figure IV-10
Poor Curb Cut Location**

Figure IV-10 illustrates a common problem in many communities—a curb cut which leads directly into a gutter pan or not with direct access to a crossing. In this case, the crossing leads into a storm drain and the actual access is off-set from the crosswalk. This stop is directly across from Safeway food store.

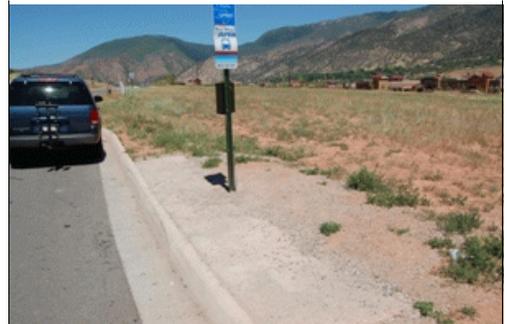
**Figure IV-11
Poor Access to Stop**

Accessibility to transit stops is, as mentioned, a crucial part of mobility for the disabled. Figure IV-11 provides an example of poor access to a transit stop in Glenwood Springs. The current access is along the shoulder of the road which is comprised of gravel or packed stone/sand. It is currently impossible to travel to the stop in a wheelchair; the shoulder material can become soft and un navigable during rain or snow. The shoulder also tends to have ruts or other obstacles such as larger stones which makes access difficult for those in wheelchairs. Using the road to access the stop becomes hazardous for all pedestrians.

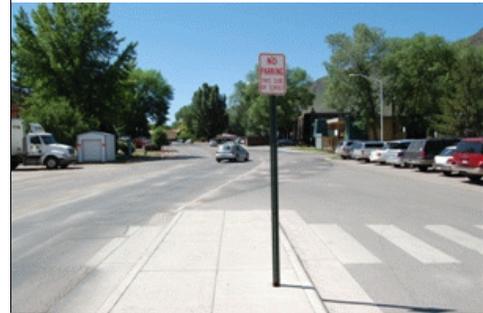
**Figure IV-12
Lack of Curb Cuts**

Figure IV-12 presents a photograph of a pedestrian crosswalk which is not accessible. There is no existing curb cut to allow a wheelchair to mount the bus landing pad from the street. This crossing is located across from the hospital.

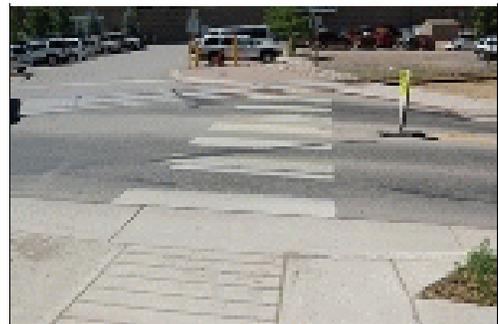
**Figure IV-13
Appropriate Crossing**

Figure IV-13 provides a look at a pedestrian crossing which is fully accessible to pedestrians. Curb cuts exist on both sides of the right-of-way, both of which are textured. The timing of lights at major intersections, especially those with a three-lane cross section (or more) should be carefully examined to allow for adequate crossing time.

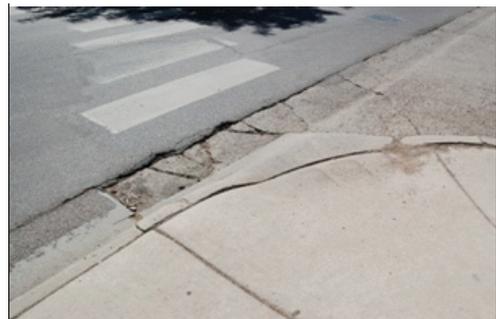
**Figure IV-14
Poor Curb and Gutter**

While curb and gutter tends not to have a significant impact on pedestrian movement, it does for persons in wheelchairs. The type of mountable curb shown in Figure IV-14 makes it difficult, but possible, for wheelchairs to cross the street at intersections; however, this is not an acceptable curb cut and crosswalk design. According to the US Access Board, all intersections where a pedestrian is likely to cross the street should be marked with a textured material to indicate a crossing to those who are sight impaired. This type of mountable curb is acceptable according to historic design standards; however, it would not meet new construction guidelines.

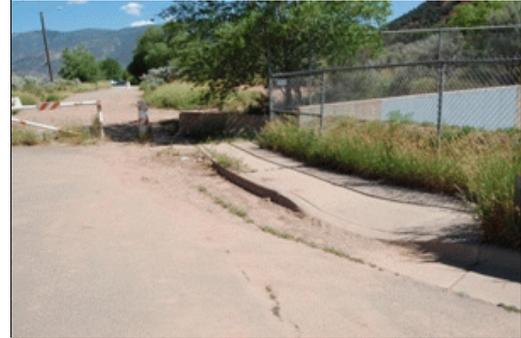
Figure IV-15
Sidewalks “that go nowhere”

Connectivity is an issue which is a high priority for the Steering Committee. As shown in Figure IV-15, there are examples of this type of development in which a sidewalk abruptly ends in a subdivision. The subdivision in this illustration is directly behind the local Wal-Mart. Several pedestrians were observed using this area to access transit and Wal-Mart.

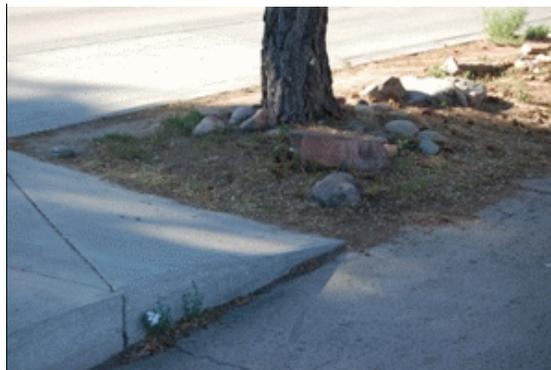
Figure IV-16
Poor Ramp Access

Figure IV-16 shows a “ramp” to provide transition between a stop and the sidewalk. As shown, the ramp leads into a landscaped area with several large rocks which impede access via wheelchair. Additional safety elements include crossings near schools and major intersections and the lack of curb cuts.

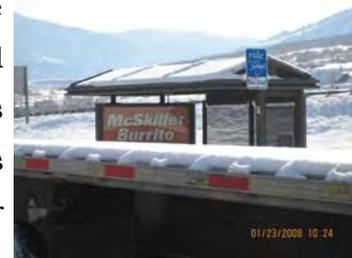
One issue which needs further emphasis is the allowance of truck parking on eastbound Highway 6 and 24 near the bus stop. As depicted in the picture, the bus stop is completely blocked by a semi-trailer truck. This is a frequent occurrence that has caused problems for bus drivers and patrons. This issue has been brought to the attention of the City Council, the Transportation Commission, and CDOT.
